Jurisdictional Determination Report

West Anchorage Snow Disposal Site

Municipality of Anchorage – Project
Management & Engineering

November 11, 2020

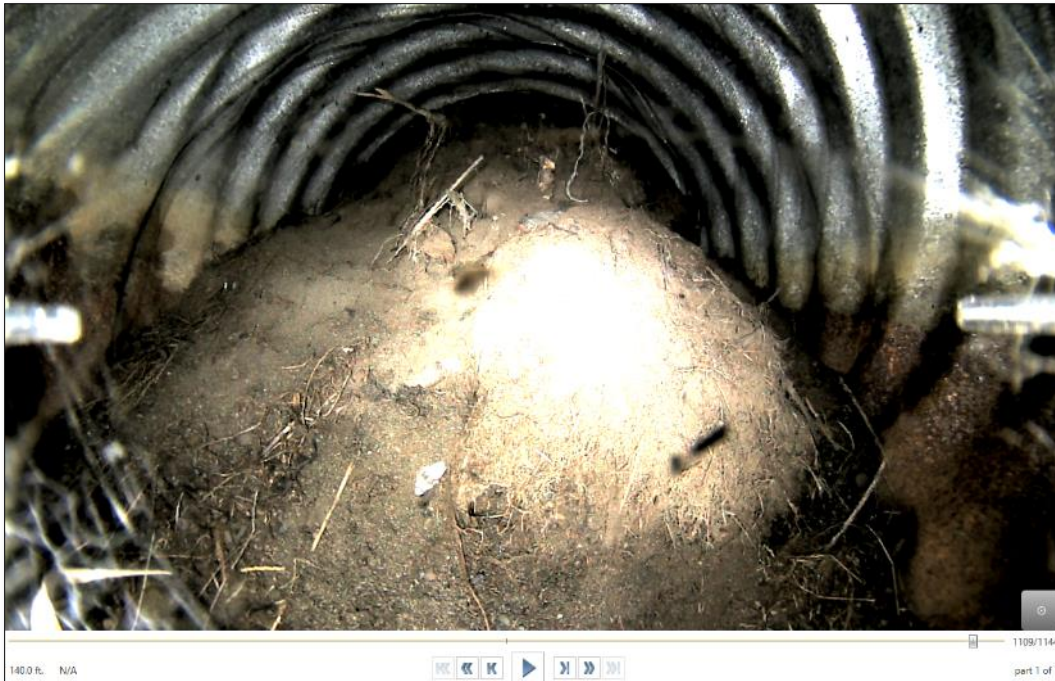
Inset 2. Blockage in Raspberry Road culvert

As described in Section 2.1, the north end of a known culvert through Raspberry Road could not be located (SW1). MOA Street Maintenance owns a mobile device fitted with cameras that can provide a high definition 360-degree view of pipes to assess their overall condition. MOA Street Maintenance was able to enter the south end of the culvert and move the device approximately 140 feet north under Raspberry Road. At that point a plug of soil and fill material was encountered and causes an apparent full blockage of the north end of the culvert (Inset 2). MOA Street Maintenance staff inspected the north embankment with a metal detector and found the

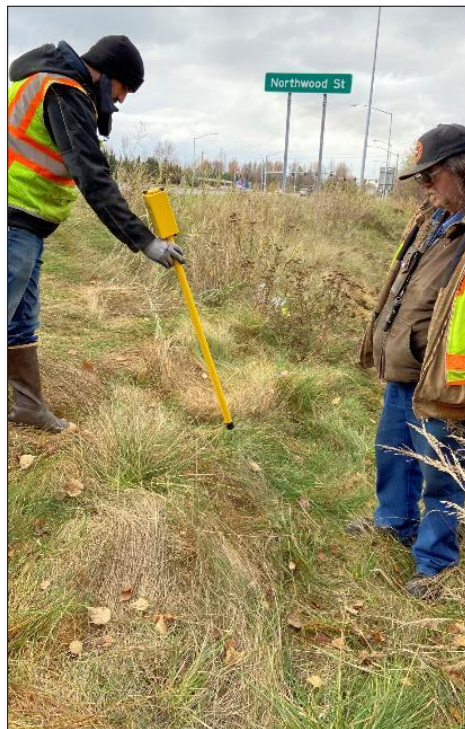
Inset 3. MOA staff detecting the north end of the culvert under Raspberry Road

apparent north end of the culvert, which was covered with several feet of road material (Inset 3). A full report of the culvert inspection performed by MOA Street Maintenance is provided in Appendix D.

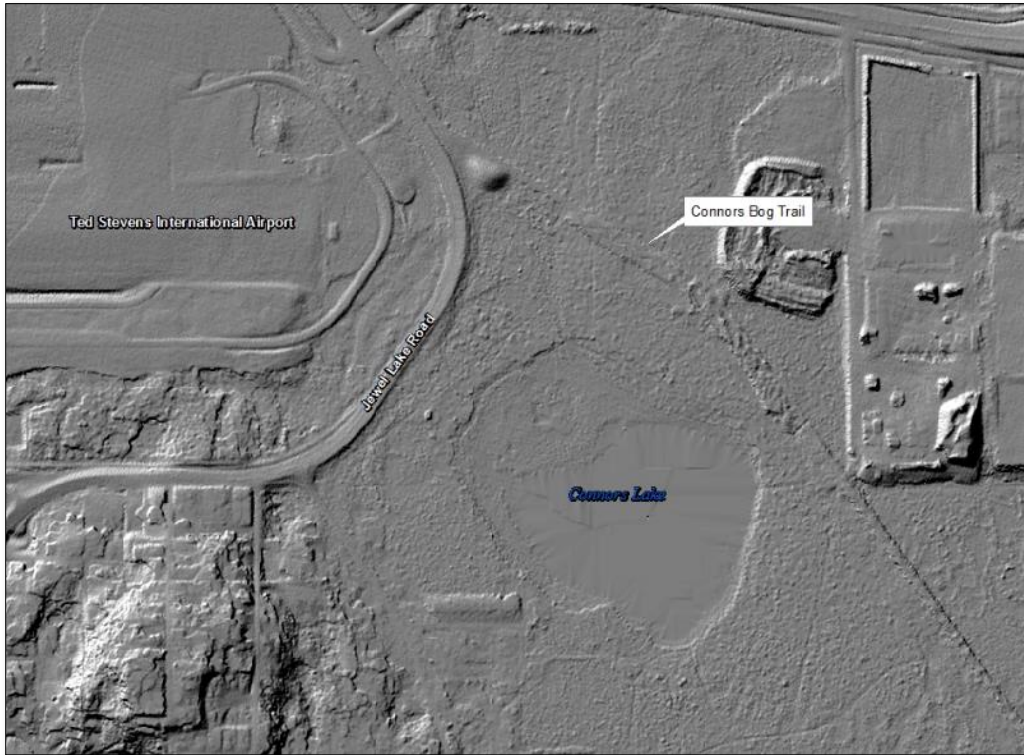
Inset 4. 2-foot LiDAR hillshade of area around Connors Lake

In order for Connors Lake to meet the definition of a WOUS, a surface water connection of any size and type would be required to flow from the lake to a jurisdictional water. Aerial imagery and topographic data show that there are no clear outlets from Connors Lake that would contribute surface water through any other WOUS or non-jurisdictional surface water features. As shown in Inset 4, the lake lies in a depressional area and is bounded by surface development. Field investigation of the area (Figure 6) found that there are no streams, culverts or other features that would allow surface water to flow out of Connors Lake to any WOUS.

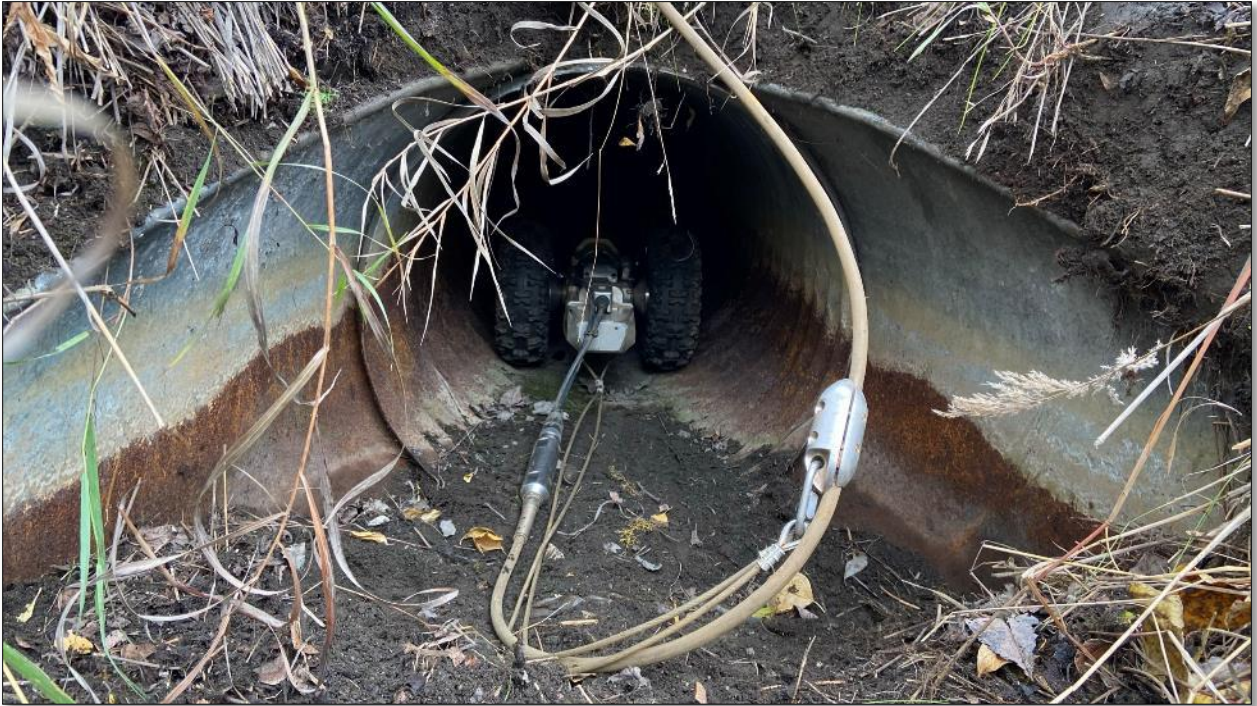
Site ID	Potential Surface Water Connection	Field Observations
SW1	Culvert through Raspberry Road visible in MOA Drainage Viewer (Drainageway ID 1436-11-1)	North end not found. Investigated by MOA Street Maintenance staff. See Inset 2. South end has rust from occasional flooding in Strawberry Bog but north end is buried in the road prism.
SW2	Storm pipe from catch basin in median of Raspberry Road visible in MOA Drainage Viewer (Drainageway ID 1436-10-1)	Dry culvert, overgrown.
SW3	Storm pipe through Raspberry Road visible in MOA Drainage Viewer (Drainageway ID 1436-11-1)	Dry culvert, overgrown.
SW4	Culvert through Raspberry Road visible in MOA Drainage Viewer (Drainageway ID 1436-17-1)	Connors Bog side of culvert. Dry and overgrown with grass.
SW5	Culvert through Raspberry Road visible in MOA Drainage Viewer (Drainageway ID 1436-17-1)	Minnesota Drive catch basin side of culvert. Dry and overgrown with grass.

SW1. South end of culvert under Raspberry Road

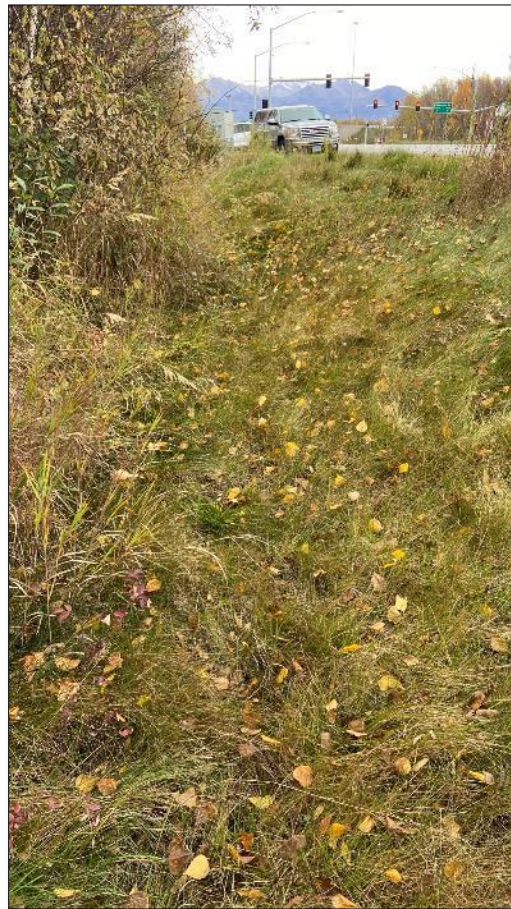
SW1. Looking east at ditch on north end of buried culvert under Raspberry Road embankment

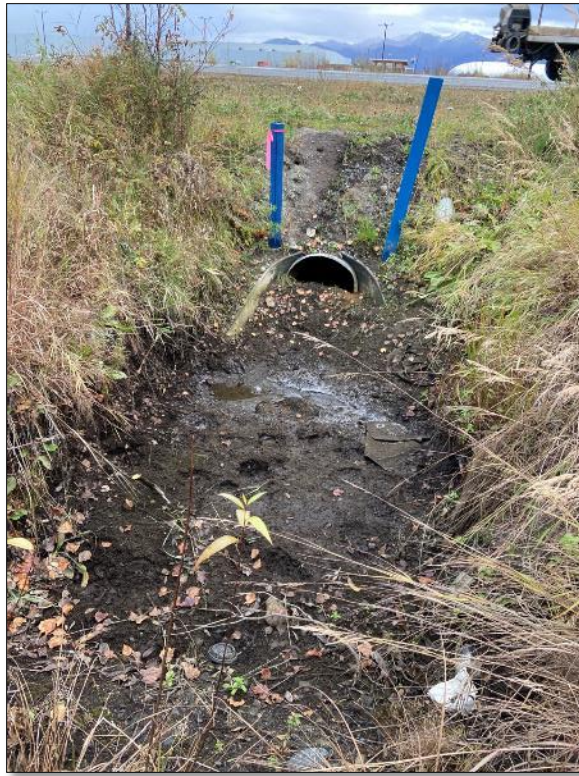
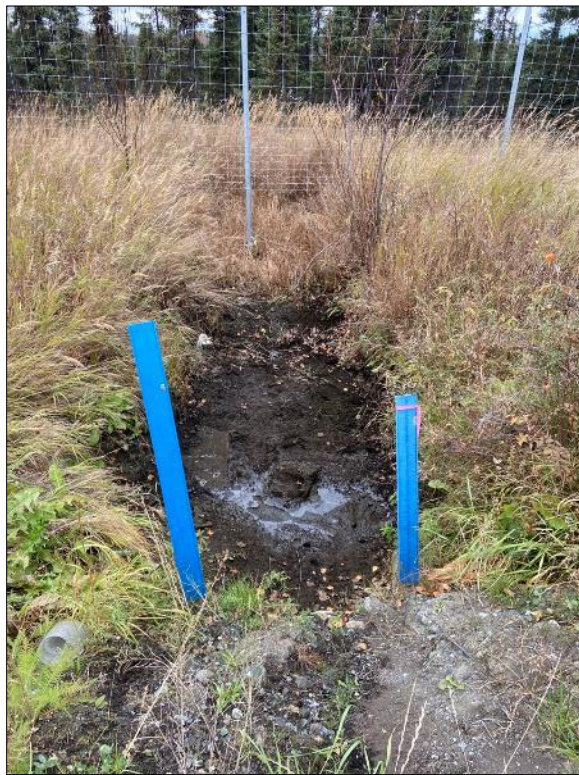
SW6	Culvert through Minnesota Drive visible in MOA Drainage Viewer (Drainageway ID 1436-15-1)	Appears to flow toward Connors Bog but may only reach it during very high water conditions.
SW7	Northern extent of wetlands in Connors Bog, north of Connors Lake	No surface outlet(s) found.
SW8	Ditch along Jewel Lake Road	Disturbed, fill substrate. Higher in elevation than wetlands.
SW9	Topographic high with trail leading into Connors Bog	No channelized feature found. Several feet higher than wetlands to south.
SW10	Culvert through Frontage Road visible in MOA Drainage Viewer (Drainageway ID 1280-57-1)	Ditch and culvert dry. No channel development within ditch. Likely for snow storage and spring runoff.
SW11	North side of same culvert through Frontage Road visible in MOA Drainage Viewer (Drainageway ID 1280-57-1)	Ditch and culvert dry. No channel development within ditch. Likely for snow storage and spring runoff.

SW6. East view of culvert through Minnesota Drive

SW6. West view on top of culvert through Minnesota Drive

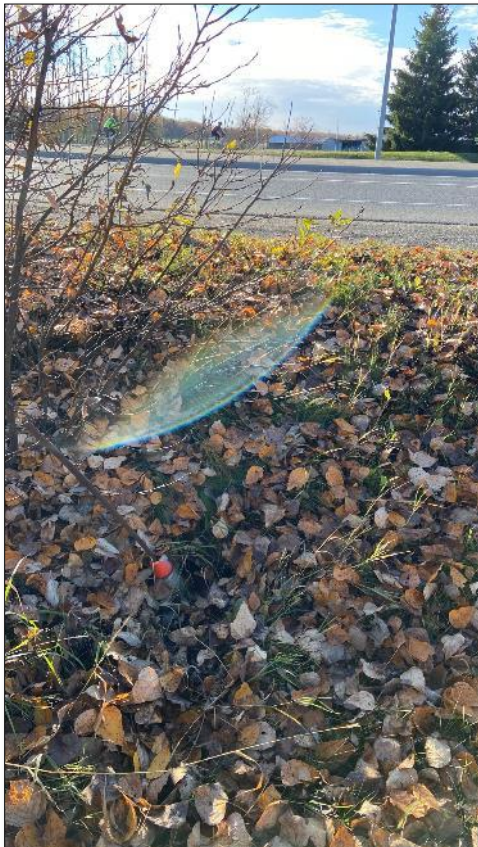
SW12	Culvert through Jewel Lake visible in MOA Drainage Viewer (Drainageway ID 1280-56-1)	Small culvert ~10" diameter. Dry and overgrown. Likely for runoff.
SW13	Northern extent of ditch along Jewel Lake Road	No channelized features found. Large, open field.
SW14	Culvert through Collins Way visible in MOA Drainage Viewer (Drainageway ID 79-40-1)	Culvert drains ditches along Jewel Lake Road and flow into Connors Bog.
SW15	Storm pipe visible in MOA Drainage Viewer (No Drainageway ID)	Storm pipes from neighborhood discharge here into catch basin.
SW16	Culvert through AWWU Sewer Line Trail	Connects wetlands east of the trail to the wetlands west of trail. Small diameter (12") and sits ~1 foot above wetland surface.
SW17	General site conditions of Connors Lake	Lake level apparently low. No outlets observed while walking perimeter of lake.

SW12. Looking southwest at small culvert under Jewel Lake Road

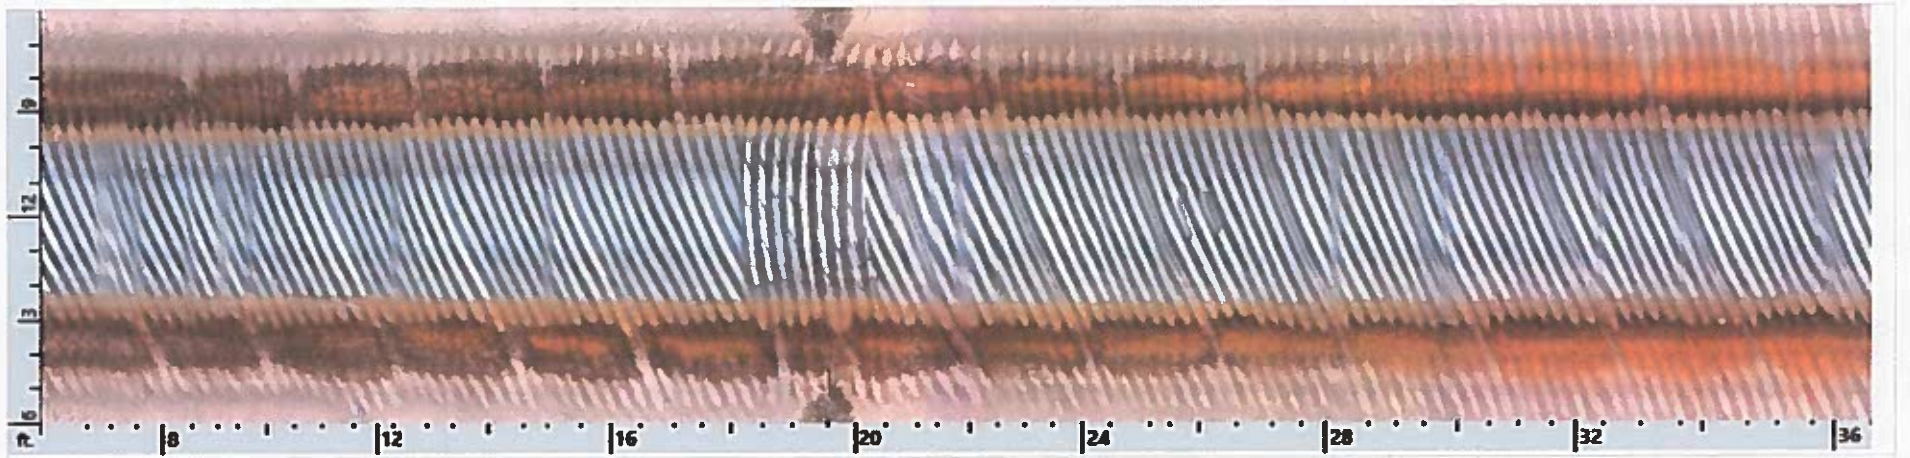
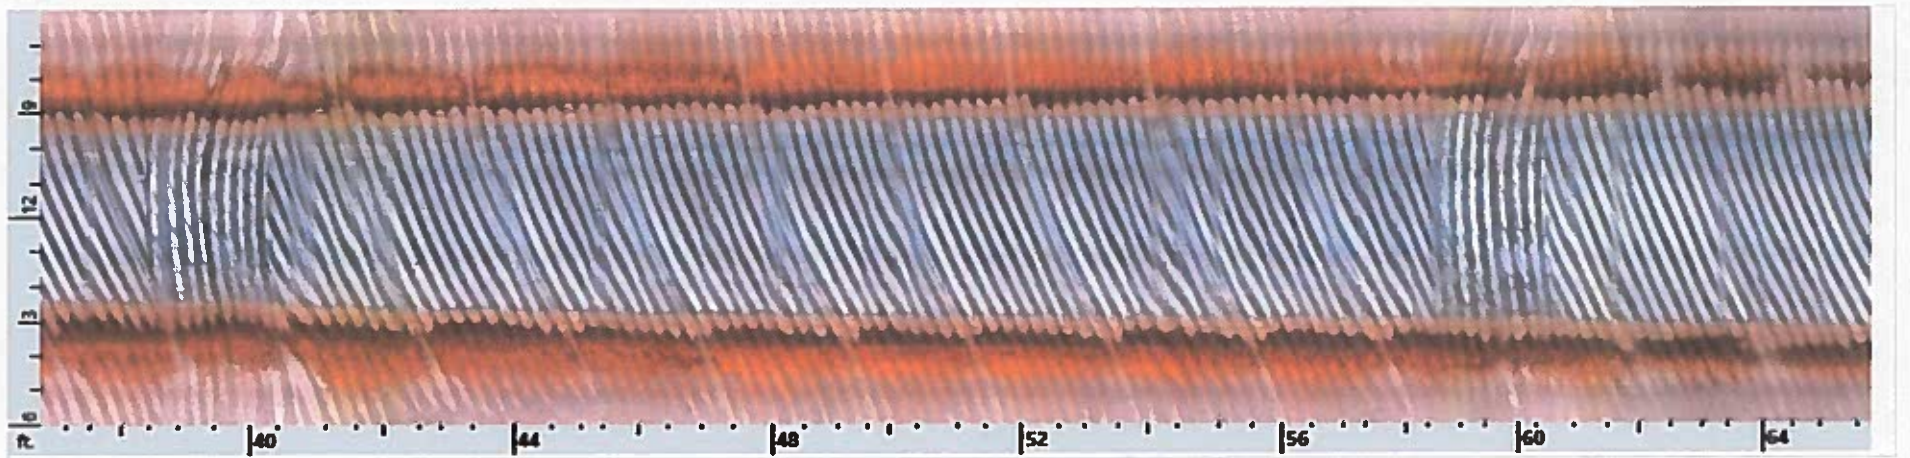
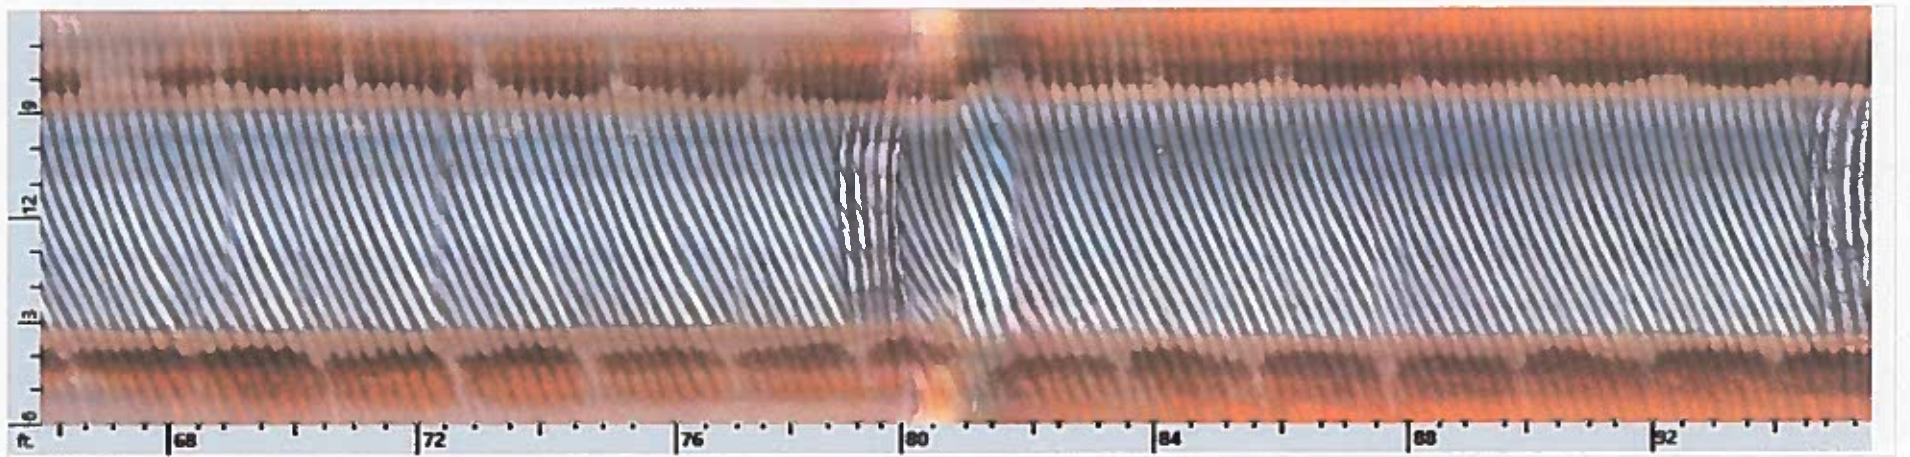
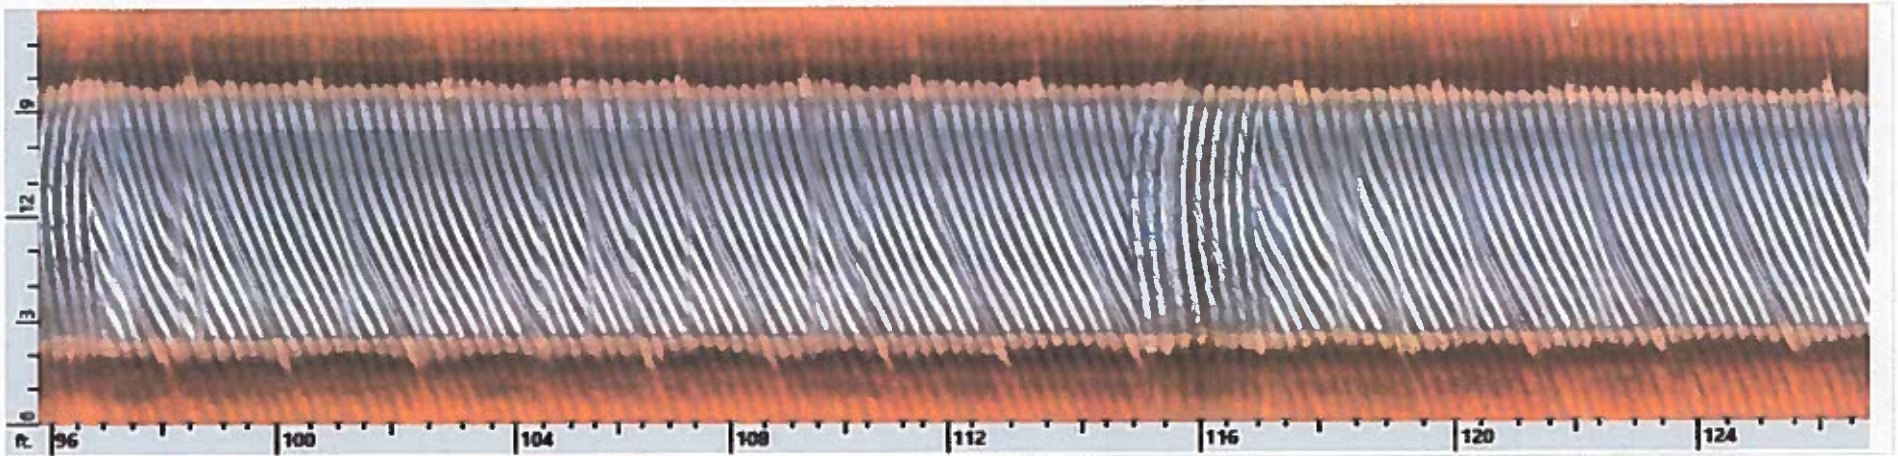
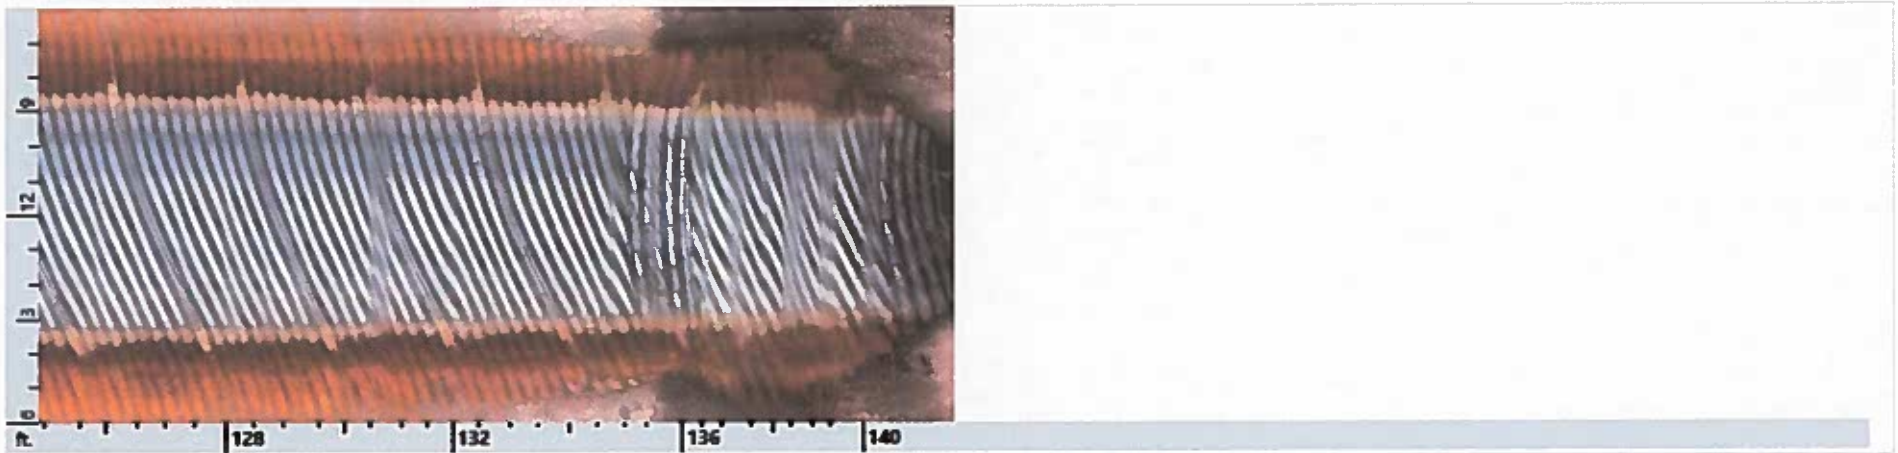
Main Inspections Flat Images

Project name: **2128** Mainline ID: **Raspberry unknown** City: **Anchorage** Address: **Raspberry east of Northwood drive**
Start date/time: **10/14/2020 1:07 PM** Pipe width: **24.0 in.** Pipe height: **24.0 in.** Pipe material: **Corrugated** Surface condition: **Asphalt** Direction: **Against the flow** Surveyed distance: **139.7 ft.** Weather: **Dry** Media label:

Distance	Dir.	Length	From/To	Code	Modifier/Severity	Rating	Comments
6.4 ft.	U		6 /	Water Level	<25%		
10.0 ft.	U		/	Water Mark	>=50%		
83.0 ft.	U		/	Water Mark	>=50%		
132.8 ft.	U		6 /	Debris	<=10%		
139.7 ft.	U		/	Debris	>30%		Pipe completely obstructed
